Report to the Test Director

**EVALUATION OF VARIOUS TYPES
OF PERSONNEL SHELTERS EXPOSED
TO AN ATOMIC EXPLOSION**

**Sandia Corporation
Albuquerque, New Mexico**

May 1956

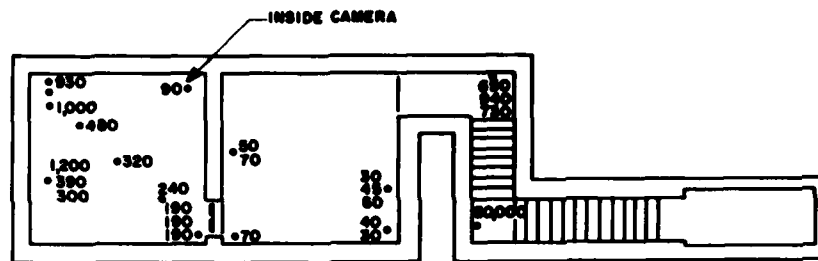
Fig. 2.4—Gamma radiation (in roentgens) in underground personnel shelter (biomedical), open shot; Station 34.3 b-2, 1050 ft.

Estimated incident radiation (Fig. 2.1) was 57,000 r; thus the 50,000 r measured in the stair well (Fig. 2.4) was nearly the full incident dose. The average of three readings at the landing of this shelter was more than five times the average of the readings at the same location on the closed shelter (34.3 a-2). This is a measure of the shielding effectiveness of the re-

inforced-concrete sliding door covering the closed shelter. The reading at the foot of the stairs is significantly below that at the landing. Readings inside the fast-fill side varied from 30 to 70 r.

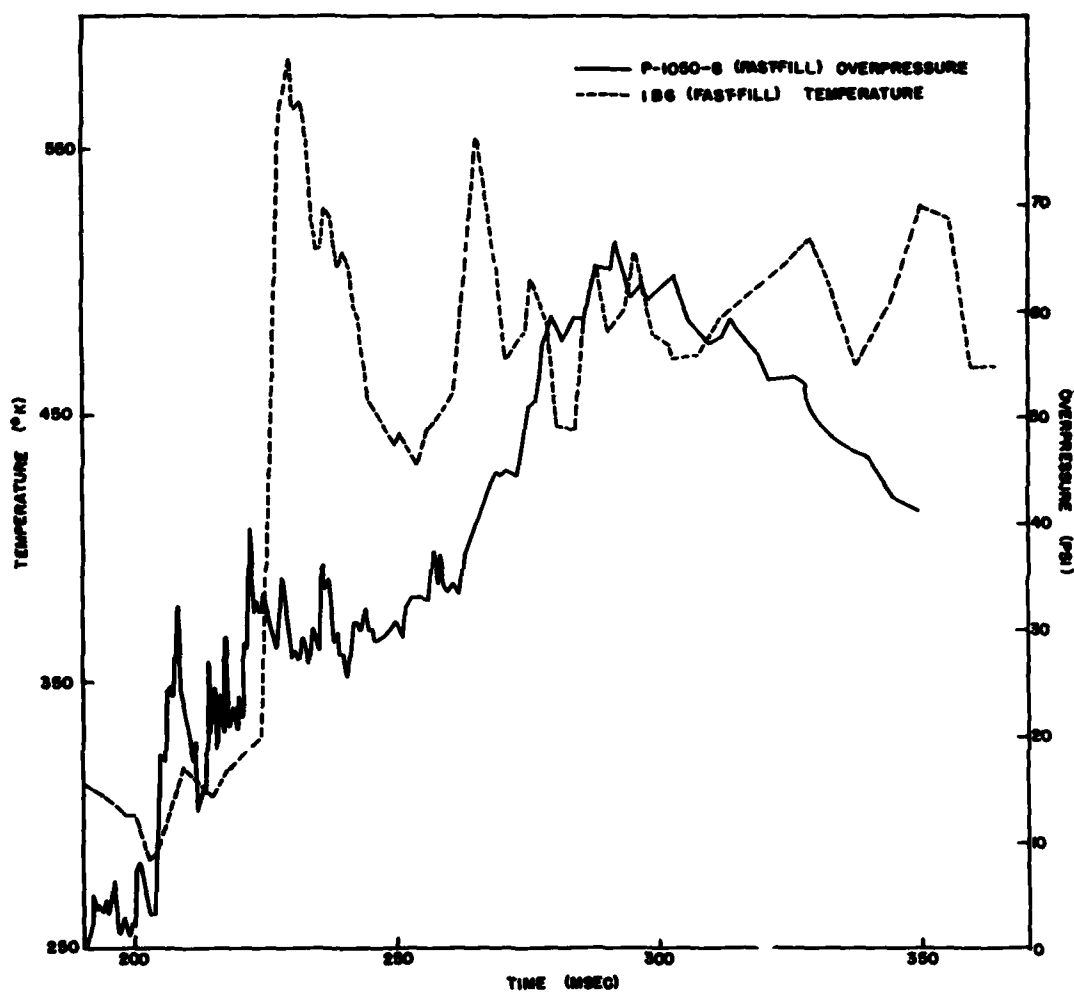
Fig. 3.1—Temperature and overpressure in fast-fill room, underground personnel shelter, open shot; Station 34.3 b-2.

Records obtained on the open shot are reproduced in Figs. 3.1 and 3.2. Errors involved in reducing the records are no greater than ± 7 per cent of the temperature in degrees Kelvin. It is uncertain whether the "hash" [for example, gauge 2A2 (Fig. 3.2) between 240 and 310 msec] is a high-frequency temperature transient or a spurious reading caused by turbulence or dust. Such high-frequency transients would not have been noted before because thermocouples used on earlier tests are not capable of responding to small transient pulses in air. These transients, if they are real, are of such short duration that their contribution to burning of occupants is offset by equal downward transients, and the average is probably the only significant temperature. Peak temperatures in the shelters are shown in Table 3.1.

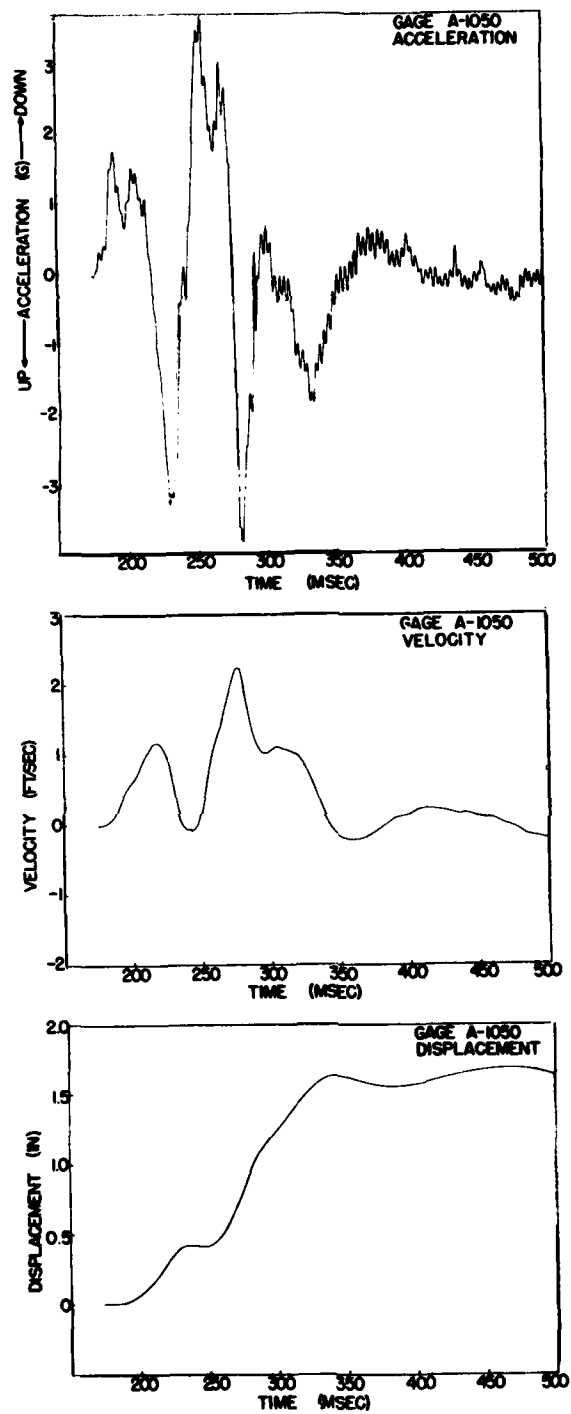
Fig. 4.1—Acceleration, velocity, and displacement records, underground personnel shelter, open shot.

Based on free-soil accelerations on earlier tests,¹ a maximum vertical acceleration of 25 g had been expected, but the measured vertical acceleration had a maximum positive (downward) acceleration of only 3.7 g (Fig. 4.1). This gives a maximum positive velocity of 2.2 ft/sec and a maximum downward displacement of nearly 1.7 in. occurring at 470 msec (Fig. 4.1). Since all the displacement was downward, these accelerations should cause no harmful effect on occupants of the shelter.

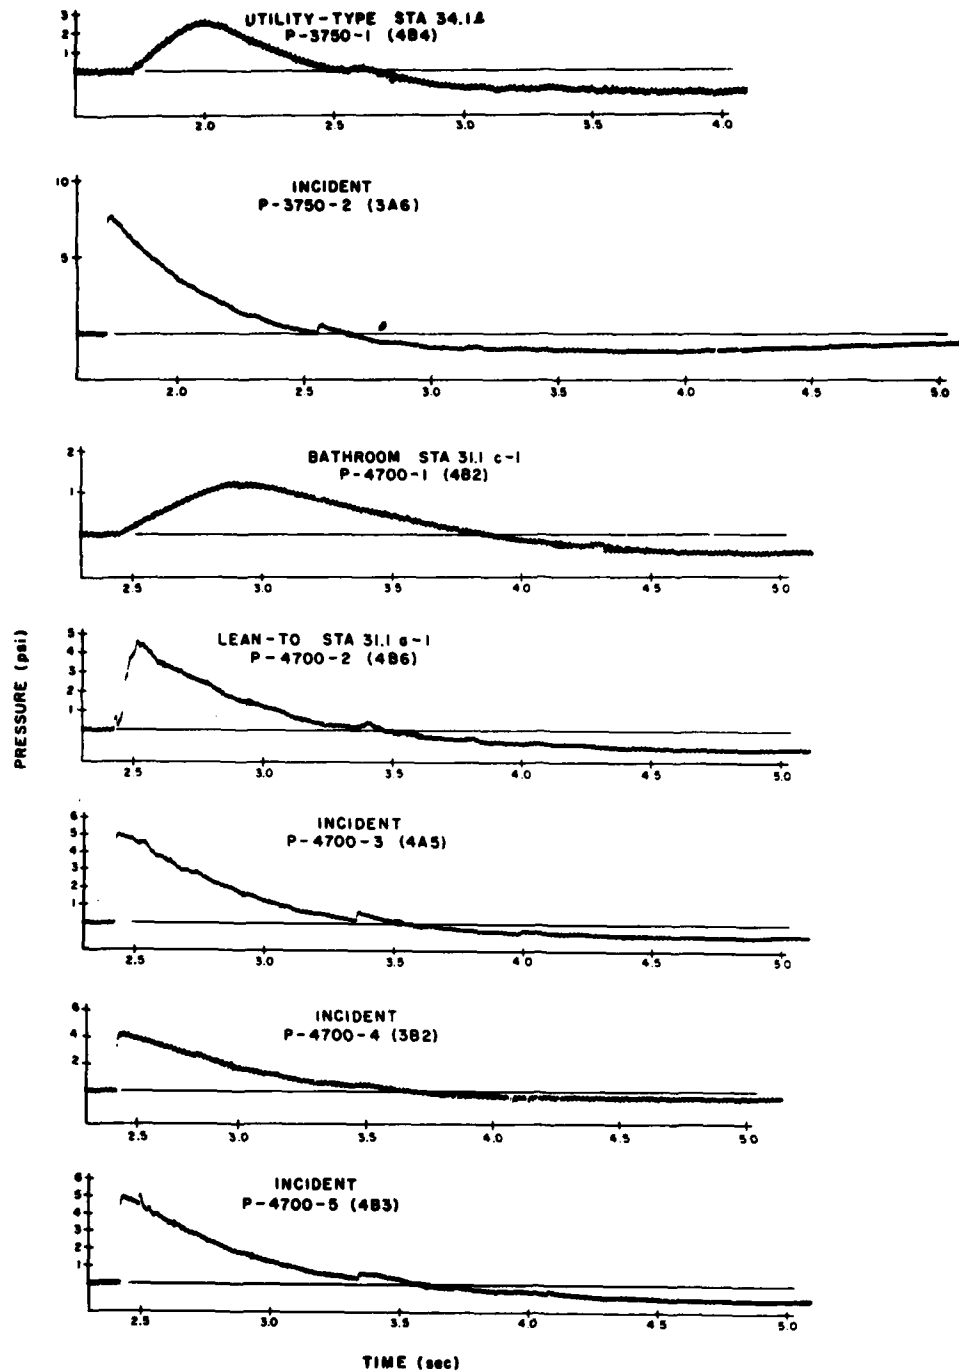
Fig. 4.2—Pressure-time records, open shot.

The rambler house at 4700 ft was subjected to an incident overpressure of 5.1 psi (Fig. 4.2). The pressure inside the bathroom shelter (P-4700-1, Fig. 4.2) rose slowly to 1.3, or to less than one-third the peak incident overpressure, then decayed slowly. For incident overpressure records taken at 10,500 ft, where the last bathroom shelter was located, see Fig. 4.3.
